# Hydraulic Simulation of Erosion and Scour at Cunas Bridge, Huamancaca Chico District, Chupaca-Peru

## ABSTRACT

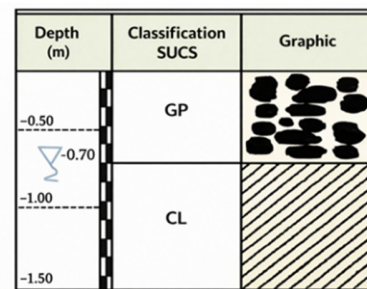
Fig. 2. Stratigraphic profile of borehole No. 01.

Figure 2 presents the stratigraphic profile of test pit No. 01 at station 000+011 upstream. According to the Unified Soil Classification System (USCS), the upper layer is classified as Poorly Graded Gravel (GP). This layer consists of moist, gray gravel with a soft consistency, containing blocks ranging from 3" to 8" in size and approximately 70% subrounded clasts. The groundwater table is encountered at a depth of -0.7 m. At a depth of -1.5 m, the underlying layer is classified as Low-Plasticity Clay (CL). This layer is saturated, dark reddish-gray in color, and exhibits a soft consistency.

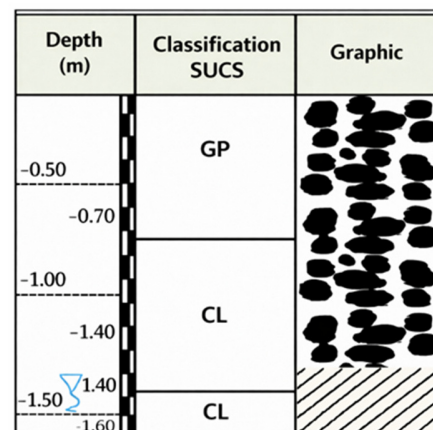
Fig. 3. Stratigraphic profile of borehole No. 02.

Figure 3 presents the stratigraphic profile of test pit No. 02 at station 000+156 upstream. According to the USCS, the upper layer is classified as GP. This layer consists of moist, gray gravel with a soft consistency, containing rock blocks ranging from 3" to 8" in size and approximately 70% subrounded clasts. The groundwater table is encountered at a depth of -1.4 m. At a depth of -1.5 m, the underlying layer is classified as CL, which is saturated, dark reddish-gray in color, and exhibits a soft consistency. The stratigraphic profiles and macro-granulometric analyses provided essential input data for the hydraulic design. This approach is consistent with recent numerical and experimental studies demonstrating that hydraulic structures alter flow patterns and sediment transport processes, leading to significant morphological changes in scour holes [19]. To determine the maximum design discharges for this study, runoff curve numbers were first established as shown in Table I. In addition, comprehensive geomorphological information for the Cunas River basin was

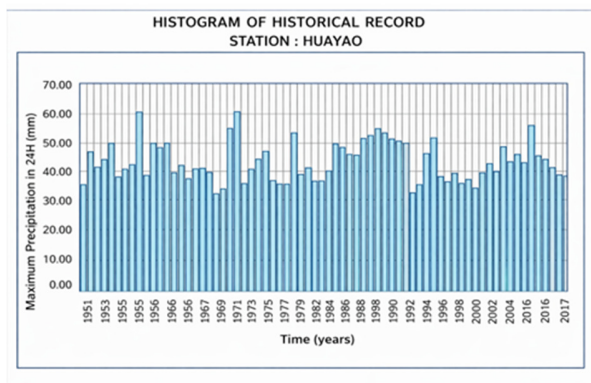
To calculate the maximum 24-h precipitation, historical records from the Huayao meteorological station were used. This station is the closest to the study area and is in the district of Huachac, Chupaca, Junín, Peru. The histogram of the historical record for the Huayao station is illustrated in Figure 4.

Fig. 4. Histogram of historical record, Huayao station.

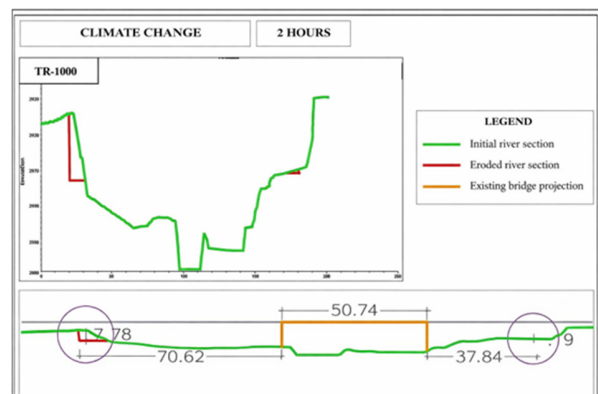
Figure 5 illustrates the hydraulic simulation of a river cross-section under a climate change scenario, considering a maximum design discharge of  $Q = 743.2 \text{ m}^3/\text{s}$  and a 100-year RP. The simulation incorporates sediment transport during an extreme 2-h event, followed by a drag period of 31 days, and compares the initial riverbed profile with the eroded profile. The results show a maximum erosion depth of 7.78 m at the upstream portion of the section, near the abutment or left pier. In addition, a secondary erosion zone is identified approximately 37.84 m to the right of the bridge, with an erosion depth of about 0.9 m.

Fig. 5. Cross-section of the Cunás River,  $Q = 743.20 \text{ m}^3/\text{s}$ .

Figure 8 displays the eroded reach of the river described in Figure 7, with a total affected length of 70.38 m. The mathematical model of the Arturo Sandez Bridge indicates that the geometry of the tributary channel, combined with the narrowing at the bridge abutments, generates a concentration of flow toward the outer edge of the left abutment. This flow concentration intensifies shear stresses, leading to progressive scouring at the base of the structure [4]. As a result, flow velocity and sediment transport capacity increase, exposing the left abutment and compromising its structural stability. This behavior is consistent with the results depicted in Figures 5 and

7, where significant erosion is observed on the left side, with maximum depths of 7.78 m and 5.54 m, respectively.

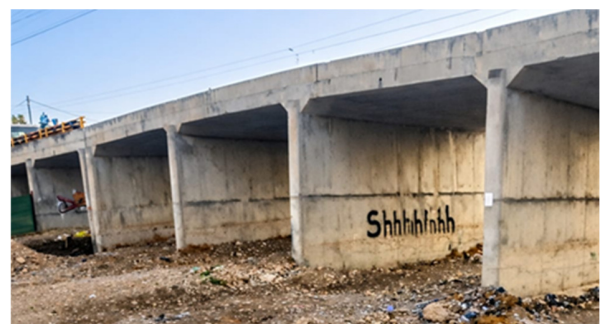
Fig. 6. Initial erosion section of the bridge.

Figure 6 illustrates the initial section of the river channel, where the erosion process is evident in both climate change and historical scenarios. Under the climate change scenario, an erosion depth of approximately 7.78 m is observed because of increased discharge and flow energy. In contrast, the historical scenario shows an even greater erosion depth, indicating progressive degradation of the riverbed near the bridge area and greater vulnerability of the structure to extreme hydrometeorological events.

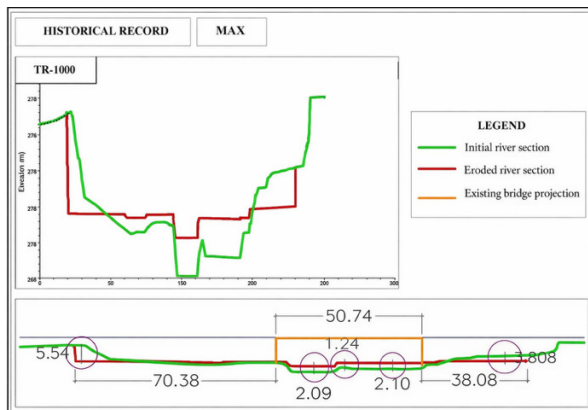
Fig. 7. Transverse section of the Cunas River,  $Q = 372.2 \text{ m}^3/\text{s}$ .

Figure 7 presents the initial river section for a maximum design discharge of  $Q = 372.2 \text{ m}^3/\text{s}$  under a historical scenario with a 100-year RP, including sediment transport. The eroded river reach can be identified, with an erosion depth of 5.54 m at the initial section. On the right side of the bridge, another eroded reach is observed with a depth of 3.81 m. Finally, the average erosion depth along the entire length of the bridge reach is 1.81 m.

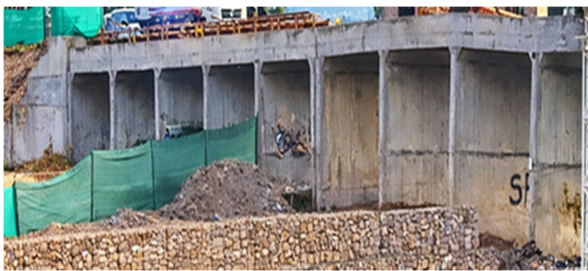
Fig. 8. Eroded reach.
