A Study on the Retrofitting of the Shear Capacity on Cold Joint Longitudinal RC Beams

ABSTRACT

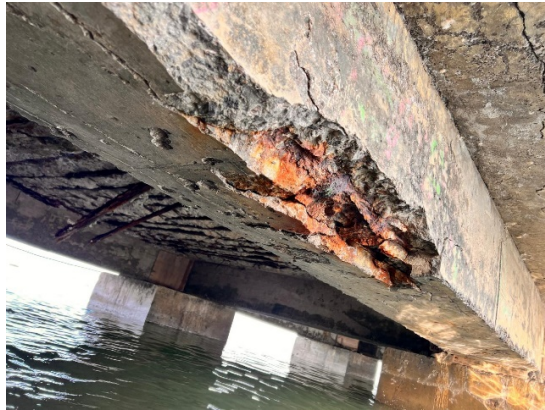
Fig. 1. Spalling of RC beams due to corrosion.

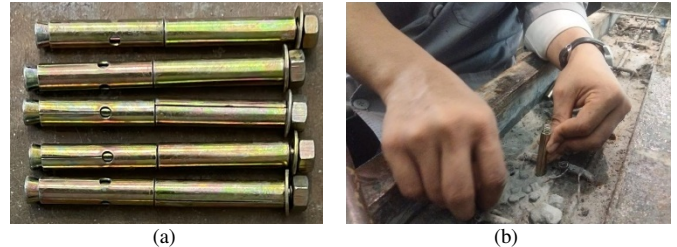
was to transfer external tensile and shear forces at the joints. In this investigation, M10 dyna-bold anchors with a post-installed system were utilized. This anchor is available in the local market. The post-installed anchorage system involved inserting anchors into the hardened concrete by drilling holes, ensuring efficient and convenient installation, as depicted in Figure 2.

Fig. 2. (a) Dyna-bold anchors, (b) installation.

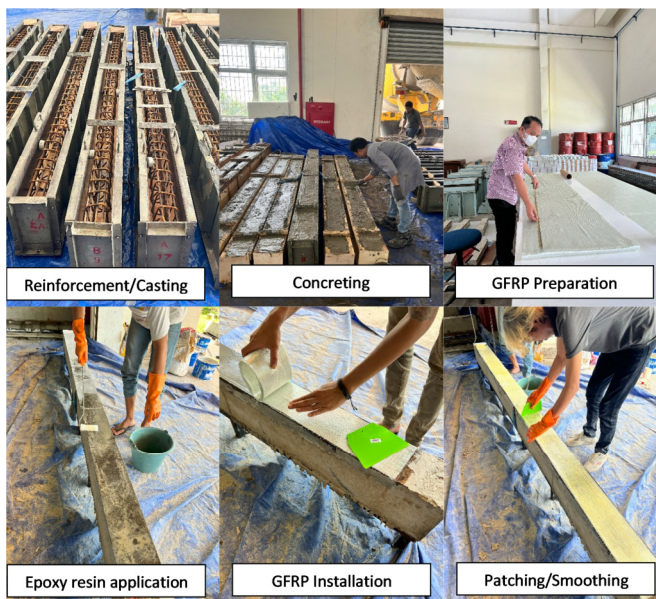
The process of making beam specimens starts with normal concrete casting and water curing until the age of 28 days, then continues with grouting mortar casting [22]. After 3 days, the compressive strength of the grouting mortar reached around 70% or higher of the compressive strength of the existing concrete and then the specimen could be tested. Especially for specimens with additional dyna-bold anchors, before the grouting mortar was cast, the dyna-bolds were first embedded into the old concrete at a depth of 6 cm using a hand drill. After all the concreting processes were complete, GFRP was installed on the bottom of the beam, which has been smoothed first with sandpaper.

Fig. 4. Specimen preparation.

The process of making specimens in the laboratory is shown in Figure 4.

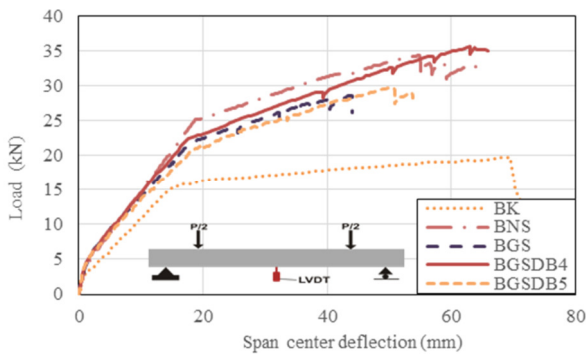
Figure 7 shows the load-deflection relationship for all specimens, showing that, initially, all beams did not crack, indicating good concrete withstand ability. As the load increased, deflection increased slowly, and as the load reached maximum, the beams began to crack. The control beam (BK) experienced yielding when the load reached 16 kN, followed by the BGSD5, BGS, and BGSD4 beams at 21 kN, 22.1 kN, and 22.5 kN, respectively. The BNS beam achieved the highest yield load at 25.2 kN due to the monolith beam's action and the GFRP sheet's reinforcement. As the load increased, yielding occurred in the reinforcement, causing a decrease in flexural stiffness in all test specimens. The BGSD4 beam exhibited the greatest load and deflection among the beams, indicating a better adhesion effect between grouting mortar and old concrete at a certain dyna-bolt anchor distance.

Fig. 7. Load-midspan deflection.

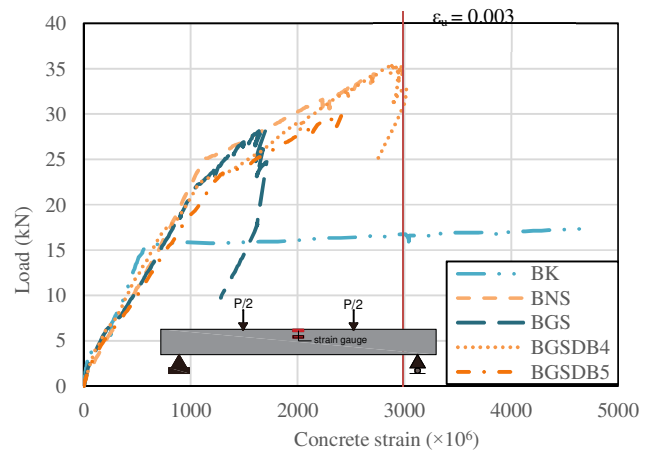
The load-strain relationship in concrete is illustrated in Figure 9, showing that no cracks occurred at the initiation of the loading test for all specimens. When the load approaches the maximum load, the strains at BK, BGSD4, BNS, BGSD5, and BGS were equal 0.0047, 0.0029, 0.0027, 0.0023, and 0.0017, respectively. The control beam BK has the highest ductility value, reaching an ultimate concrete strain of 0.003 before failure. The BGS beam has the lowest strain. Adding dyna-bold anchors to old and new concrete joints significantly increases the ultimate stiffness and strength of the BGSD4 beam by 6.62% to BNS and 41.29% compared to the beam without additional dyna-bold anchors (BGS).

Fig. 9. Load-concrete strain.
