# An Integrated Remote Sensing and GIS Road Condition Assessment Framework

Applying Geospatial Techniques to Improve Pavement Condition Analysis

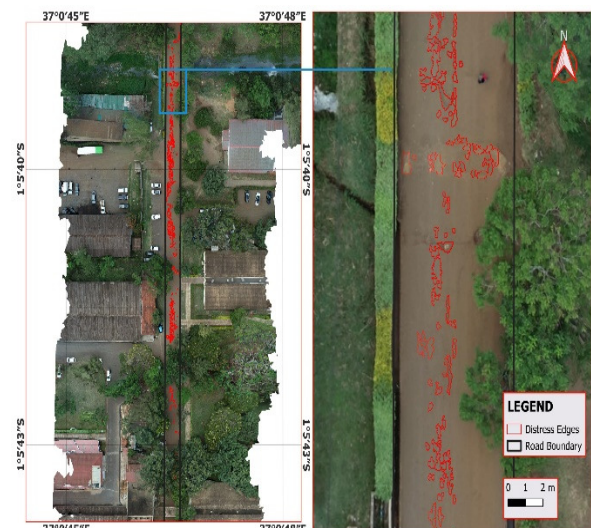
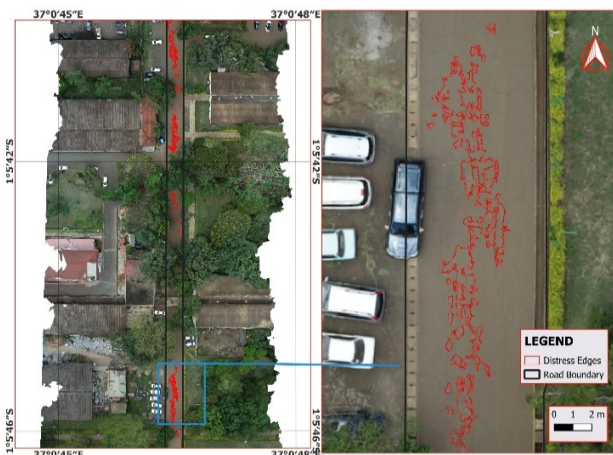
The results are presented in two stages: edge detection maps (Figures 7-10), which define the boundaries used for the distress identification, and distress classification maps (Figures 11-14), which categorize pavement distress based on severity and type.

Fig. 7. Edge detection for Innovation-Street road distress condition (upper section of the road).

Fig. 8. Edge detection for Innovation-Street road distress condition (lower section of the road).

Fig. 9. Edge detection for Technology-Street road distress condition (left section of the road).

Fig. 10. Edge detection for Technology-Street road distress condition (right section of the road).

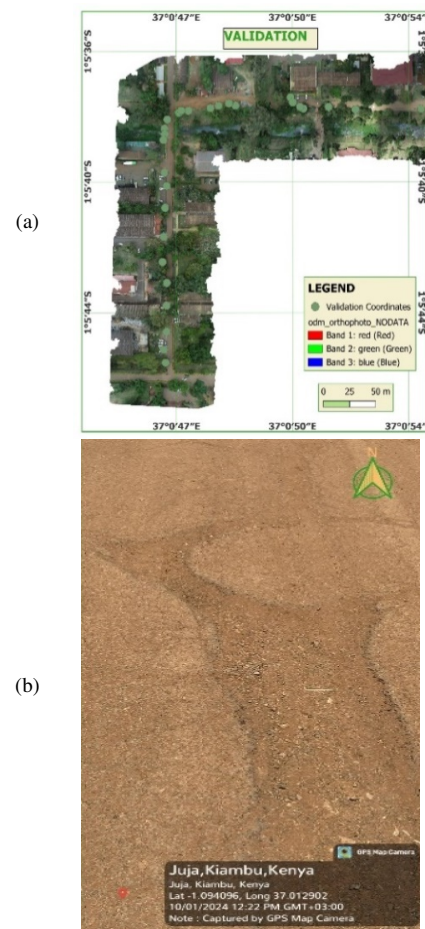
To verify the accuracy of the QGIS pavement assessment, validation points were overlaid on the orthophoto (Figure 16). These validation points align with the distress locations identified during the classification process, confirming the

reliability of the geospatial analysis. Additionally, sample images of the distress, captured using GPS Map Camera, further corroborate the accuracy of the assessment, demonstrating that the QPCI method effectively identifies and classifies pavement distress levels.

Fig. 16. (a) Orthophoto overlaid with validation coordinates, (b) Sample distress image captured using GPS Map Camera.
