# Repair and Strengthening of Cantilever Continuous Bridges using External Prestressed Cables: The Case Study of the Tan De Bridge in Vietnam

# III. CASE STUDY OF TAN DE BRIDGE

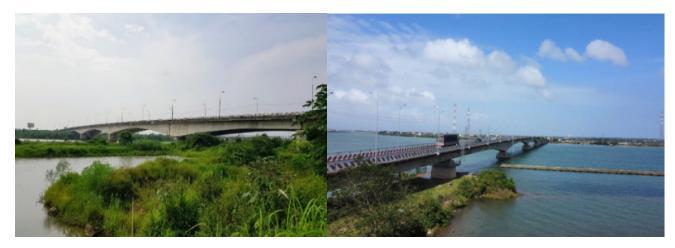
In 1996, the Phu Luong bridge, observed in Figure 1, was constructed on Highway 5 with its main span being 64.75+2×102+64.75, applying balanced cantilever technology. Next, the Song Gianh Bridge was constructed, as shown in Figure 1, along with the Phu Luong Bridge. To date, hundreds of cantilever bridges have been built with increasingly large main spans. Continuous bridges constructed employing

Fig. 1. Phu Luong, Song Giang Bridge.

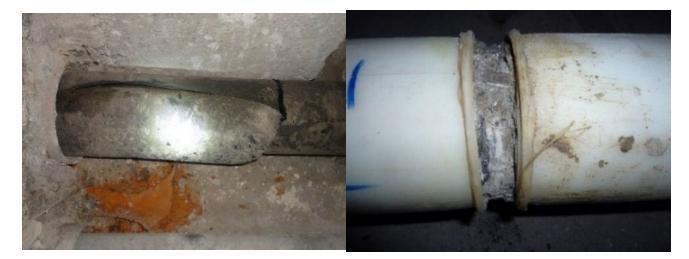
High-Density Polyethylene (HDPE) pipes are susceptible to several types of damage, including:

(1) Punctures along the HDPE pipe owing to mortar pressure.

(2) Cuts or fractions due to impacts during transportation and construction.

(3) Damage to pipe joints due to poor-quality construction.

(4) Damage at flattened diverter positions.

(5) Damage due to HDPE pipe materials not meeting the technical standards. Visual representations of these types of damage are provided in Figure 2.

Fig. 2. Damage to HDPE pipes.

A heat-activated shrinkable sheathing material can be installed to wrap and seal the damaged HPDE pipes of the external post-tensioning tendon and repair tears or cracks in the pipe body.

This method is applied to repair tears or cracks by vertically installing a new half HDPE pipe connecting it to the HDPE pipe of the external cable bundle, and then injecting mortar to cover the external cables. This method must be used when the old HDPE pipes of the external cable bundle have been removed owing to damage or when they have peeled off to check the condition of the cable strands or grout.

This method is applicable for repairing small holes or cuts by heat-welding old HDPE pipes. However, it can only be applied to repair the exterior of the HDPE pipes with small holes or small cuts. This method must be avoided when a pipe experiences water leakage or cracking. This can be caused by other factors, such as inherently defective or substandard materials. Heat welding can be utilized to restore the integrity of the HDPE pipes for the external cables used in external cable systems.

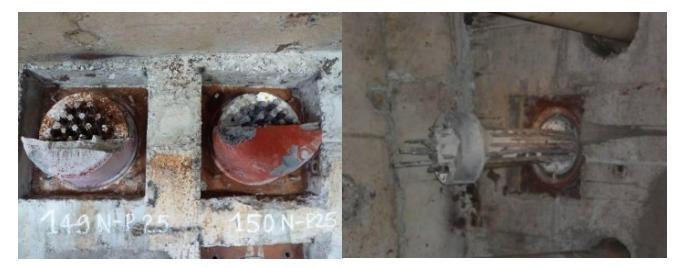
Common damage to the anchor head includes loss of the anchor head cap, insufficiently pumped mortar at the anchor head, rusting of the cable strands at the anchor head, hollow mortar at the anchor head, and anchor loss, as displayed in Figure 3.

Fig. 3. Damage to anchor head.

This procedure entails securing each anchor assembly for directly accessible anchors subsequent to the examination of the cable bundle, utilizing endoscopy, and the completion of anchor grouting. Both new construction and renovation projects have been thoroughly cleared of preexisting materials. To facilitate a direct access to the anchor within the enclosure, four levels of protection are requisite: (1) grout, (2) permanent cover, (3) seal layer, and (4) waterproof surface layer. The installation of these protective layers ensures the longevity and stability of the anchor system.

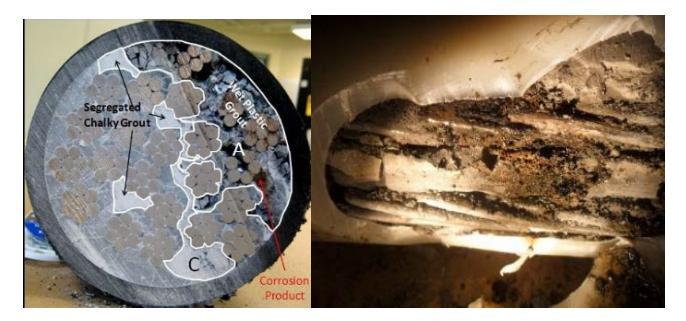
Research reports have shown that mortar voids are one of the main causes of cable-strand corrosion in prestressed systems. The typical types of mortar voids that occur in prestressed cable systems are portrayed in Figure 4.

Of these, Type 4 is usually found along the lower part of the cable bundle, whereas Types 1 and 2 are found at the top. This indicates that gravity plays a role in the layer separation of the mortar, as illustrated in Figure 4.

Fig. 4. Mortar damage on cross-section. Mortar quality is not consistent.

Currently, three grouting methods are used to pump mortar for new construction and repair mortar voids in preservative systems. Each method has its advantages and disadvantages. The Pressure Grouting (PG) method is applied with an air outlet in the hollowed pipe. The vacuum pumping method (Vacuum Grouting-VG) uses a vacuum device to pump grout into a void. Pressure Vacuum Grouting (PVG) is a repair method that combines the advantages of the VG and PG methods.

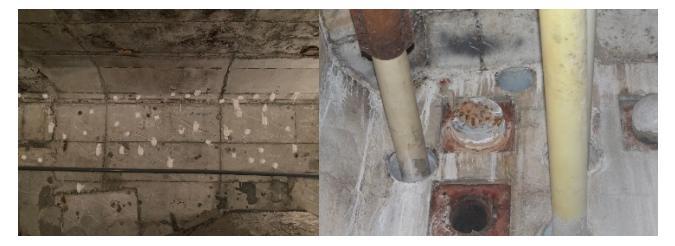
The bridge, which has been in service for over two decades, has begun to show signs of deterioration owing to increased traffic and vehicle weight. Structural damage has emerged in various parts of the bridge, including the main box-girder's interior, the web's sides, and cracks extending from the bottom to the top of the web. The deck also exhibits numerous cracks along its length. In April 2016, an external prestressed cable bundle (No. 156S) on the downstream side of span No. 8 failed and was promptly replaced. Subsequently, in January 2017, another external prestressed steel cable bundle (No. 157N) in the same span broke. This was urgently replaced following the design and construction principles used for the previous cable bundle replacement. In July 2020, an upstream external prestressed steel cable bundle (No. 156N) in span No. 8 also failed and was replaced using the same methodology as in the previous replacements [6]. In addition, the cable anchor protection box exhibited signs of corrosion. Figure 5 depicts these typical forms of damage.

Fig. 5. Some typical damages.

The fractured components of the bundles within a 5 m proximity to the cable anchor bed indicate a lack of solid mortar within the 3 m – 4 m interior range of the cable, containing only mortar foam. This absence of solid mortar allows for water accumulation, leading to rapid corrosion. Given the small diameter of the wires (5 mm), they corrode, lose their cross-sectional area, and fail first within the cable strands. The tension in the remaining strands increases due to variations in the wire quality and area; some wires break from fatigue, while others fail due to limited strength. Thus, the primary cause of cable deterioration is attributed to flawed grouting techniques, resulting in mortar foam within the inner pipe of the cable bundle near the anchor head. Water retention on the cable surface occurs due to this foam, causing rust.

Other areas of the cable bundle also contained air bubbles in the mortar. Even if mortar inspections show no voids in the sleeve, these air pockets can lead to condensation, creating surface water and an uncontrollable rust formation. The protective mortar layer surrounding the outer cable bundle is not highly reliable. Air bubbles persist even in densely pumped mortar areas, leading to moisture and a subsequent corrosion of the prestressed steel. Consequently, reinforcement creep may occur, potentially resulting in an unpredictable cable failure.

Based on the current state of the bridge, the damage to the external post-tensioning cable system is evident, affecting its ability to withstand a design load of 1.25\*HS20-44. Out of 30 external prestressed cable bundles, 27 were aged and susceptible to corrosion and degradation, with only three of them having been previously replaced. The installation of new cable bundles to replace the existing ones must adhere to specific technical standards, as outlined in [5-8]:

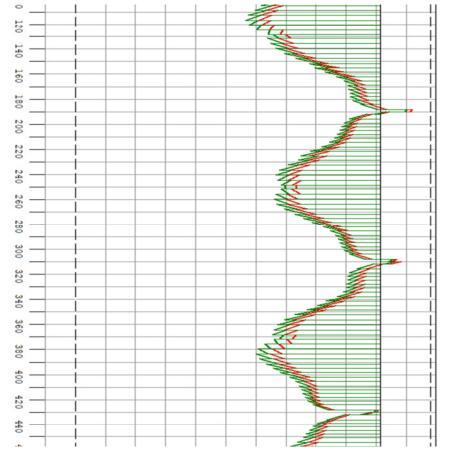
Figures 6 and 7, and Tables III and IV show the analysis results under the effect of the design load 1.25\*HS20-44.

Fig. 6. The diagram of the stress on the top flange span under a live load 1.25HS20-44.

Thus, the effect of the design load of 1.25\*HS20-44 on the stresses on the top and bottom flanges of the box girder was within the allowable stress range [9].

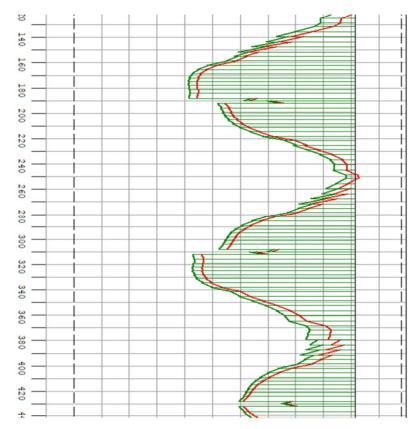
Fig. 7. The stress diagram of the bottom flanger under the box on the live load span 1.25HS20-44.

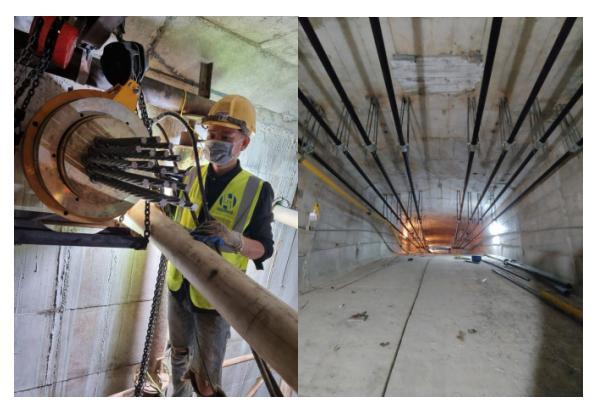
Fig. 8. Tensioning the external cable bundle Tan De Bridge.

The construction process must strictly control the tension of the cable bundle and consider the stress loss due to concrete shrinkage and creep. Figure 8 illustrates the tension of the cable bundle.
